County of Santa Cruz

DEPARTMENT OF PUBLIC WORKS

SUBJECT: RESPONSE TO NOTICE OF VIOLATION
BOULDER CREEK GOLF AND COUNTY CLUB WWTP
COUNTY SERVICE AREA NO. 7

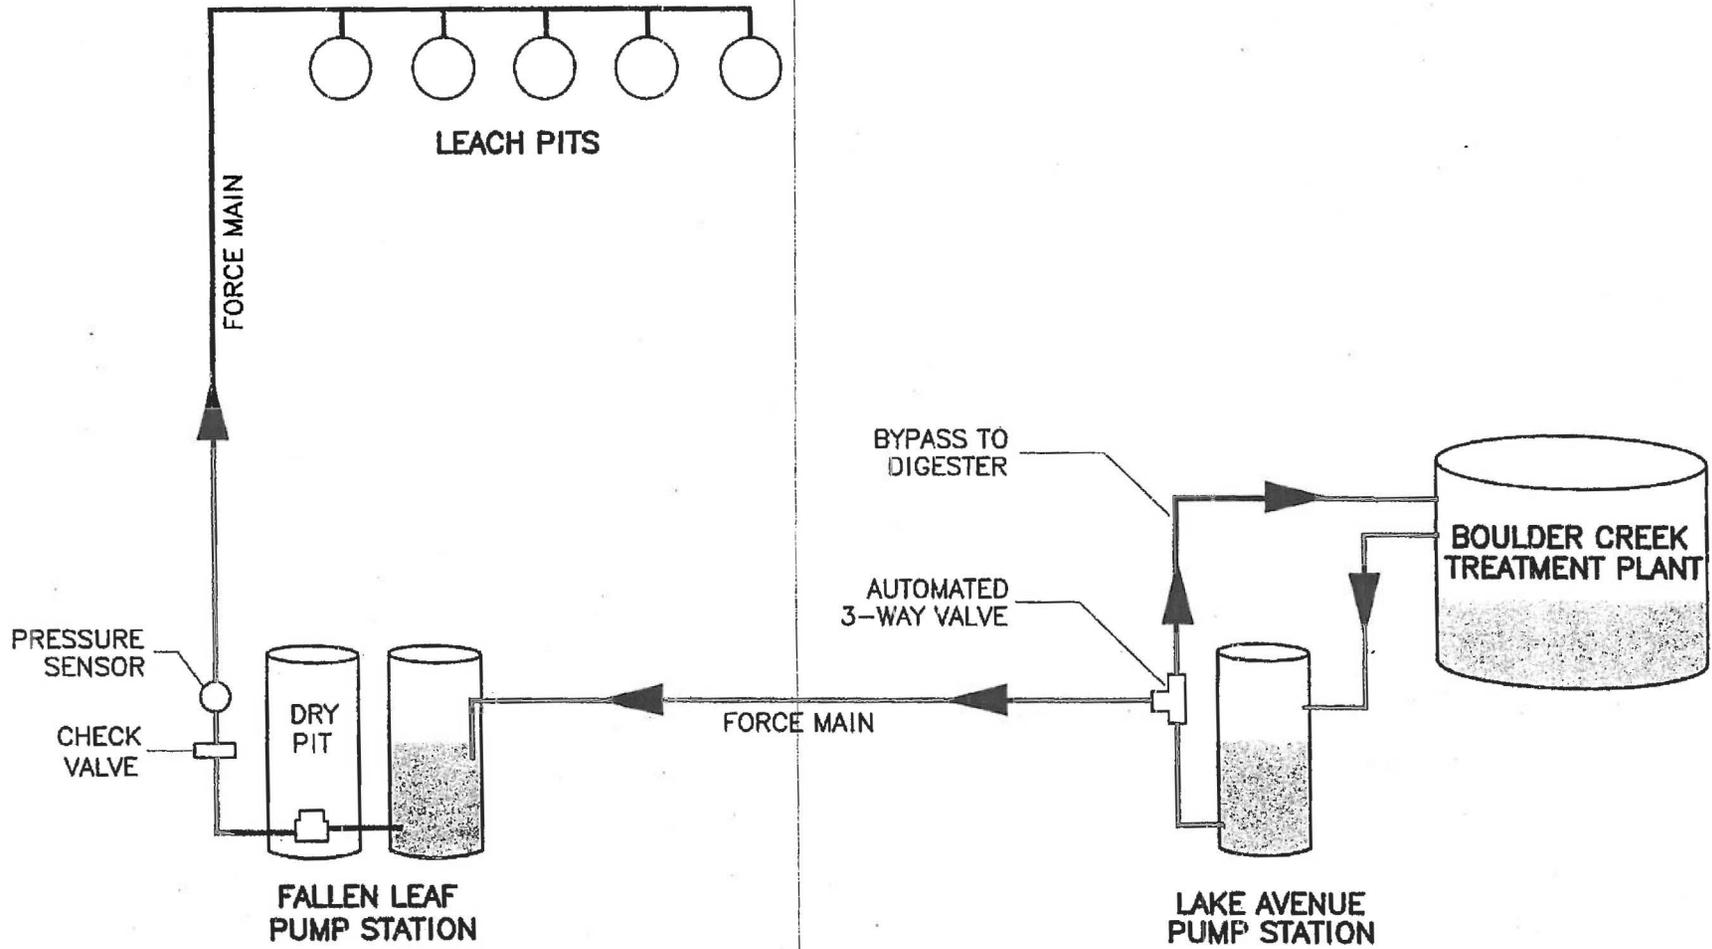
Attachment "A"

CSA #7 - BOULDER CREEK

Fallen Leaf

Spill Sampling

Fallen Leaf Pump Station
-

Wastewater Treatment Plant
-

Upstream Sample Point
-

Downstream Sample Point

General Overview and Layout (see Attachment "A")

The Lake Avenue pump station is located at the Boulder Creek Treatment Plant. Secondary treated effluent gravity flows from the plant to the pump station. From there, it is pumped approximately 4,500 feet to the Fallen Leaf pump station. The Fallen Leaf pump station then pumps the effluent 3,000 feet to leach pits.
